ARRAY MONITORING AND FIELD MAINTENANCE REPORT

Royal Norwegian Council for Scientific and Industrial Research

6 August 1973

6 PERFORMING ORG. REPORT NUMBER: NORSAR Report No. 60

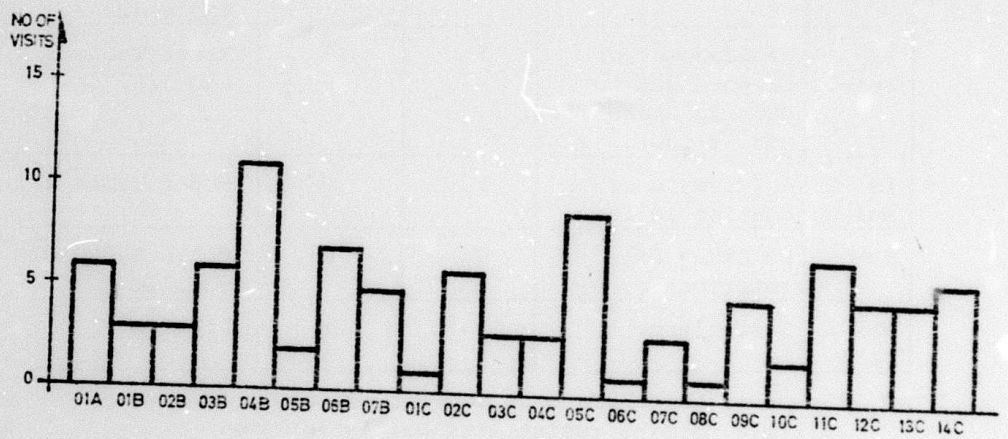
Figure 3.1 shows the number of visits to the different subarrays in the period. Excluding visits caused by troubles in the communications system, the subarrays have in average been visited 4.5 times. The larger number of visits to 04B and 05C are due to the accomplishment of different types of experiments (04B) and routine maintenance of the NAS seismic instrumentation (05C).

Figure 3.1 Number of maintenance visits to the NORSAR Subarrays (visits caused by faults in the NORSAR/NDPC communications system are not included).
